**EVALUACIÓN DE LOS IMPACTOS DEL HURACÁN
GEORGE'S SOBRE EL AGUA Y EL SUELO EN LA
REPÚBLICA DOMINICANA**
Informe de viaje del 2 al 10 de Diciembre de 1998

**RELATIVE TO THE ASSESSMENT OF DAMAGE
CAUSED BY HURRICANE GEORGES SEPTEMBER 22-23, 1998**

IN THE COUNTRY OF THE DOMINICAN REPUBLIC

TECHNICAL ASSISTANCE SHORT TERM ASSIGNMENT
TO
IICA IN THE DOMINICAN REPUBLIC
BY THE USDA NATURAL RESOURCES CONSERVATION SERVICE (NRCS)
TECHNICAL ASSISTANCE TEAM (TAT)
DECEMBER 2-10, 1998

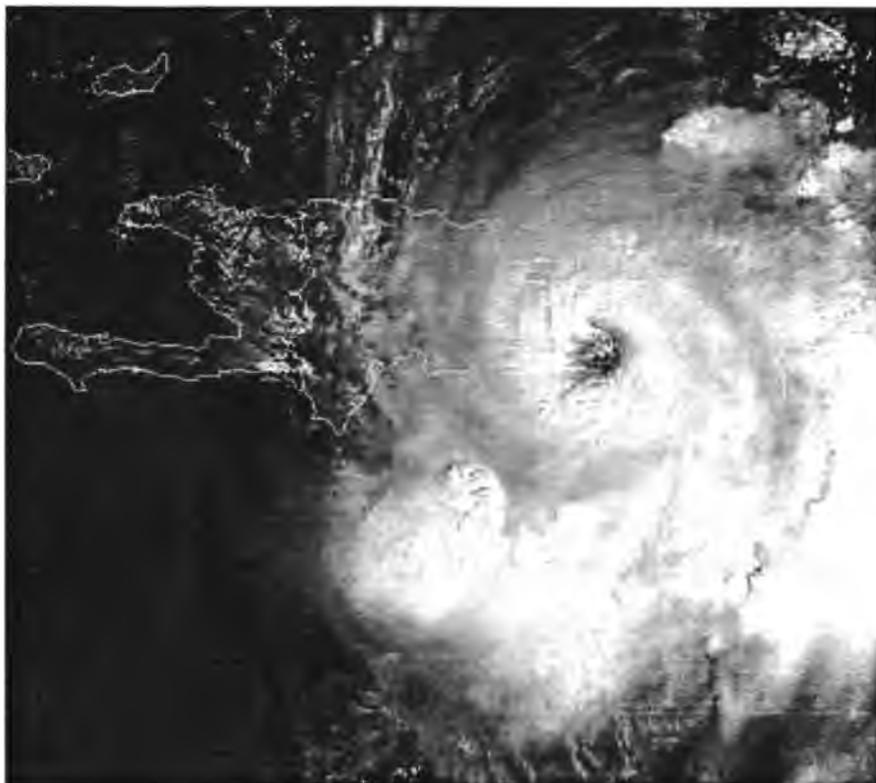
Gráfico 3
HURACÁN GEORGES AL TOCAR TERRITORIO DE LA REPÚBLICA DOMINICANA

Fuente: Imagen satelital del NWS, proporcionada por el Centro De Operaciones Conjuntas de las Fuerzas Armadas y Policía Nacional de la República Dominicana (C.O.C.)

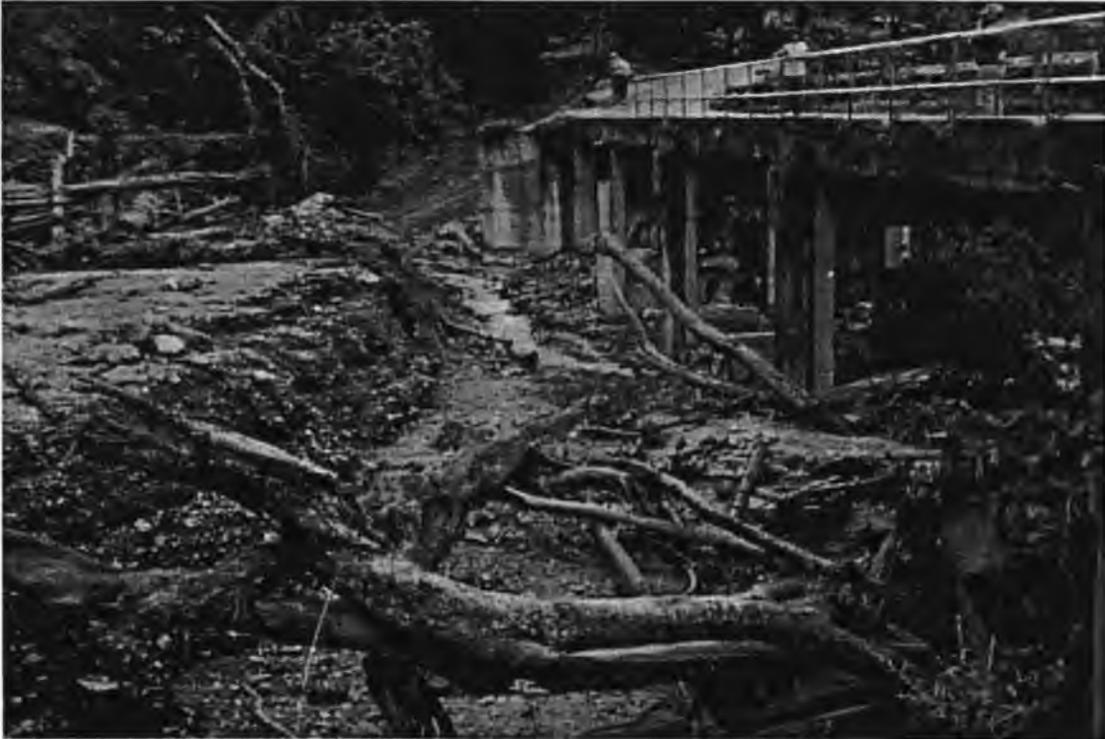
Mano Matuey, a rural village in the mountainous area of San Cristobal Province, suffered major damage. There was loss of life, homes, a school and significant damage to abutments supporting an already deteriorated bridge. Bridges such as this one occupy the only route in and out of the village.

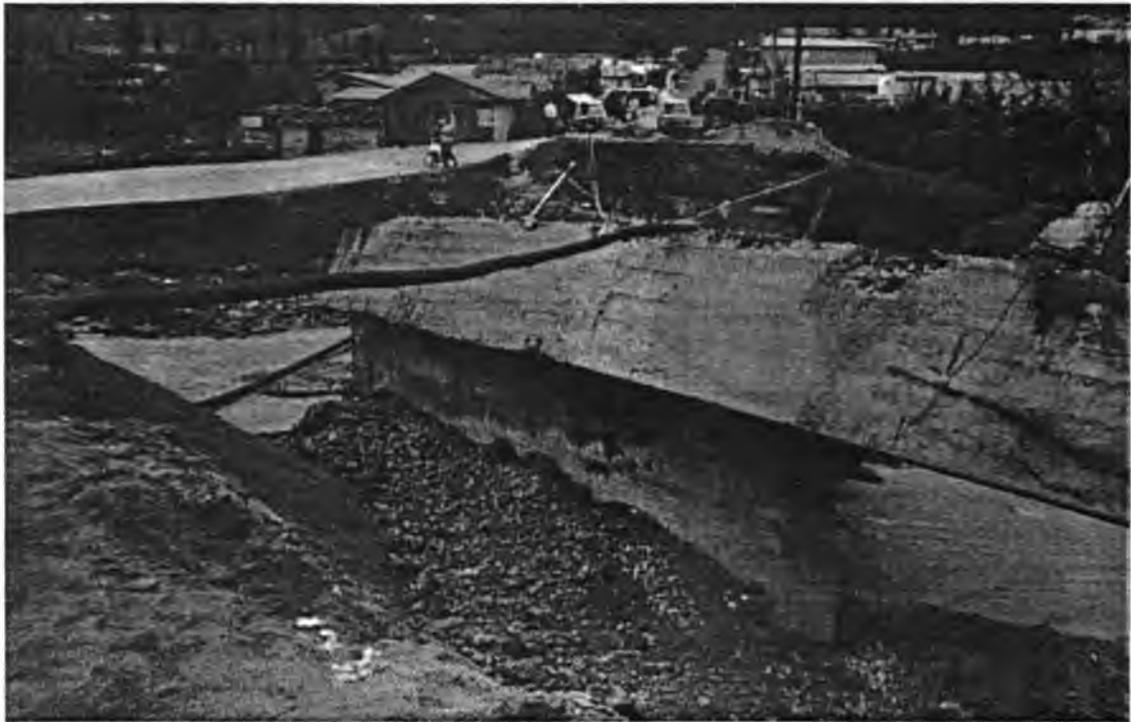
This bridge in Tireo Arriba, collapsed into the river as a result of storm damage. Debris removal began immediately in order to prevent further obstruction and a continued threat to loss of life and property. This is considered an exigency or urgent action.

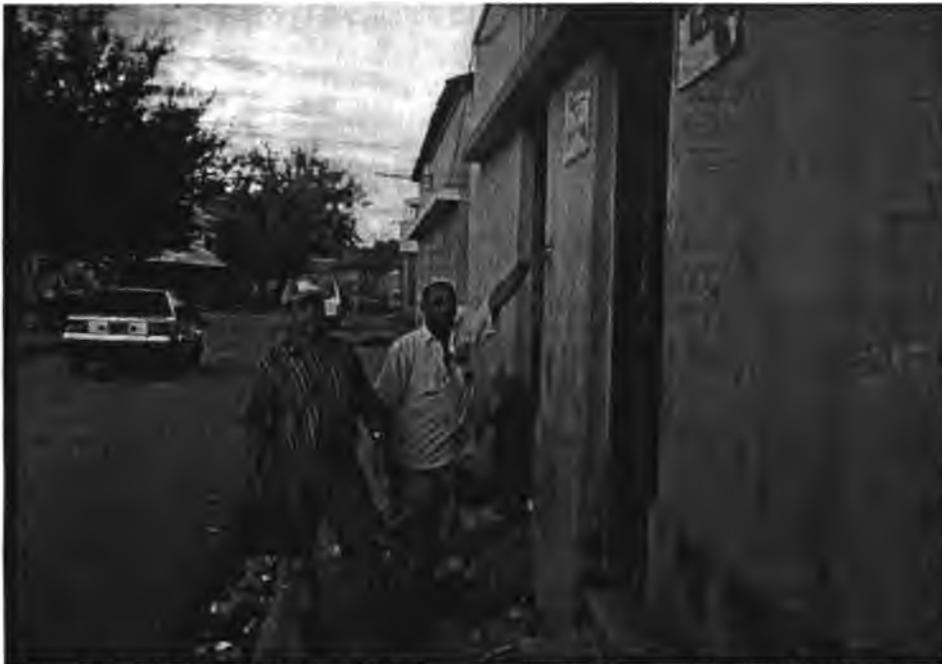
Manuel Rosales, NRCS Agronomist (l) and a villager document the height of floodwaters. This village, Tamayo, is in Baoruco Province. Tamayo suffered considerable flood damage with the height of floodwaters reaching 2 meters or more. Sediment accumulations of nearly 1 meter were recorded. Businesses lost inventory and buildings collapsed as a result of flooding. Loss of life was light compared to other areas of the country.

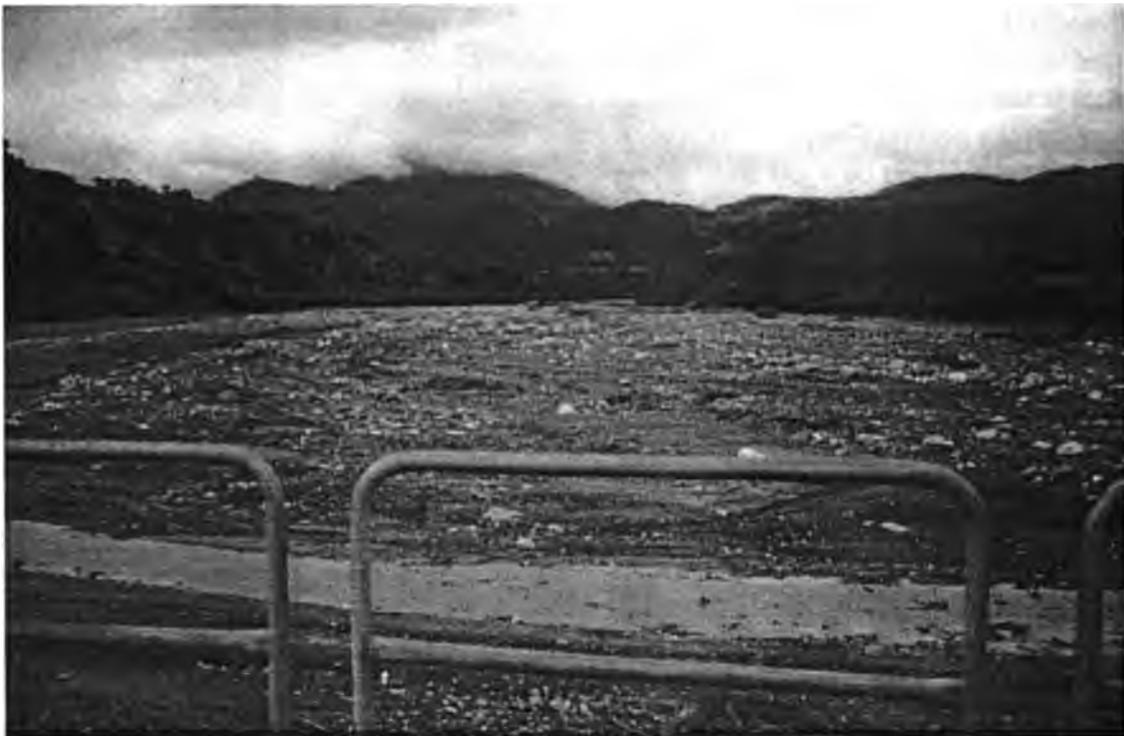
In the case with Hurricane Georges, changes in channel width were influenced by previous channel disturbances, such as channeling and changes in the riparian vegetation that may have altered the boundary resistance and susceptibility of erosion. Other changes in stream flow regimes due to changes in the watershed; and finally changes in the sediment budget are also important.

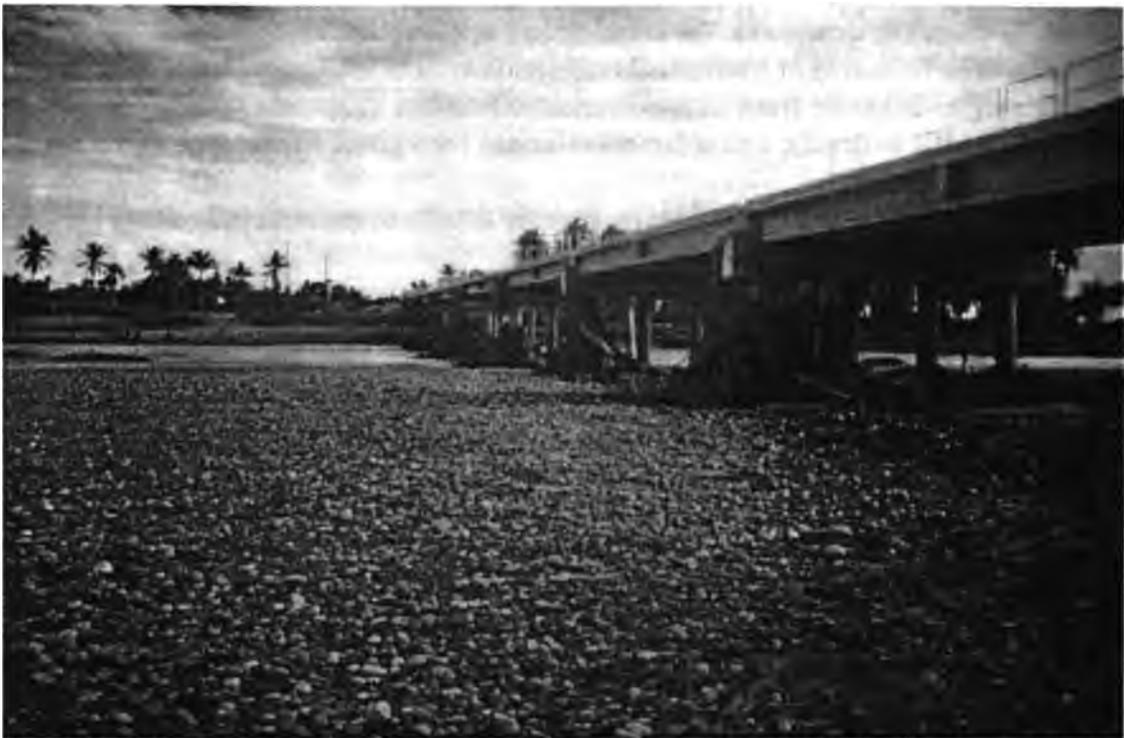
The slope of the river channel, width, volume of water and the nature of the bed and bank material differed at each location.. Common to nearly all sites was the large volume of material deposited in the channel. In addition, large volumes of floating debris rafted during high flow and became lodged against bridge abutments and pylons. This created additional force against abutments and pylons. In some cases the rafted material completely blocked flow under bridges and culverts and caused failure of these structures.

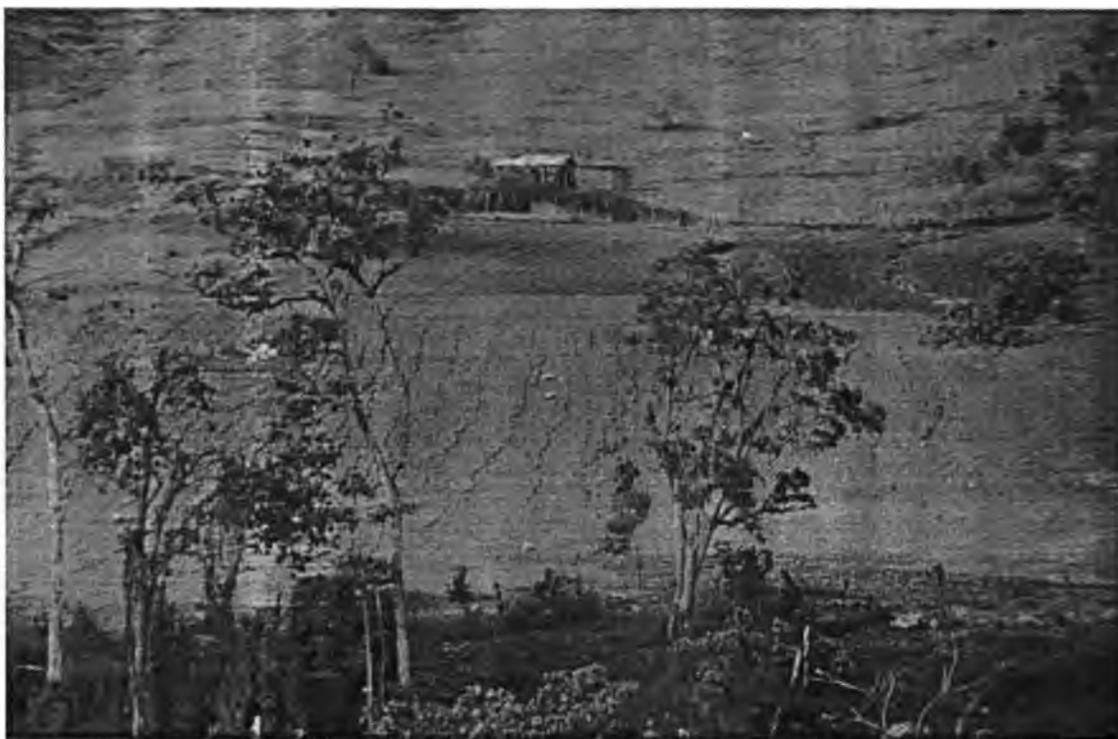
Some soils are more susceptible to rill and gully erosion than others. The absence of a soil survey makes it difficult to predict how soils will respond to certain treatments. A national soil survey program will provide land users and those who make land use decisions with soil survey information necessary for understanding, managing, conserving, and sustaining the limited soil resources of the Dominican republic. Soil surveys provide an orderly, on the ground, scientific inventory of soil resources that includes maps showing the extent of soils, and data about the physical and chemical properties of those soils.

It is recommended that efforts to continue with developing a national soil survey be continued. Basically, a national soil survey program would provide consistent reliable

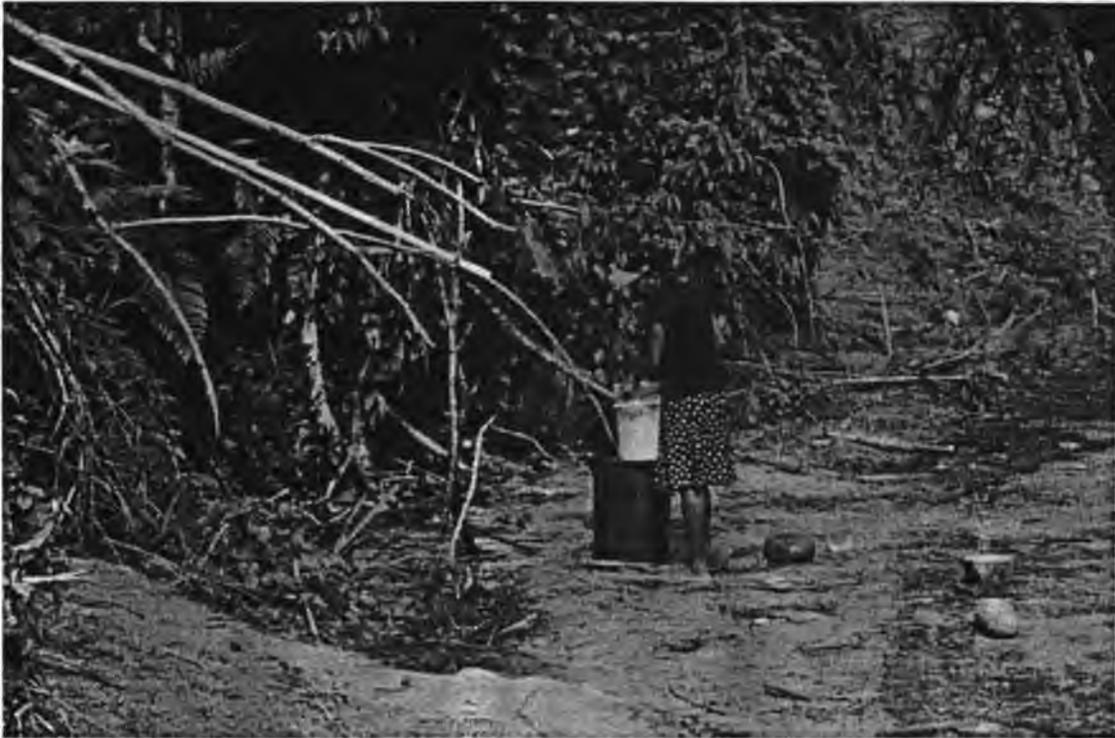
Natural resource disasters that cause earth movements frequently cut off or destroy shallow sources of water used by villagers for household use, livestock watering, and small scale, home garden irrigation. The threat of pollution to these water sources greatly increases, as does the chance of illness caused by water borne disease. Inexpensive water holding facilities and water distribution systems can reduce the occurrence of illness caused by polluted water after storm events.

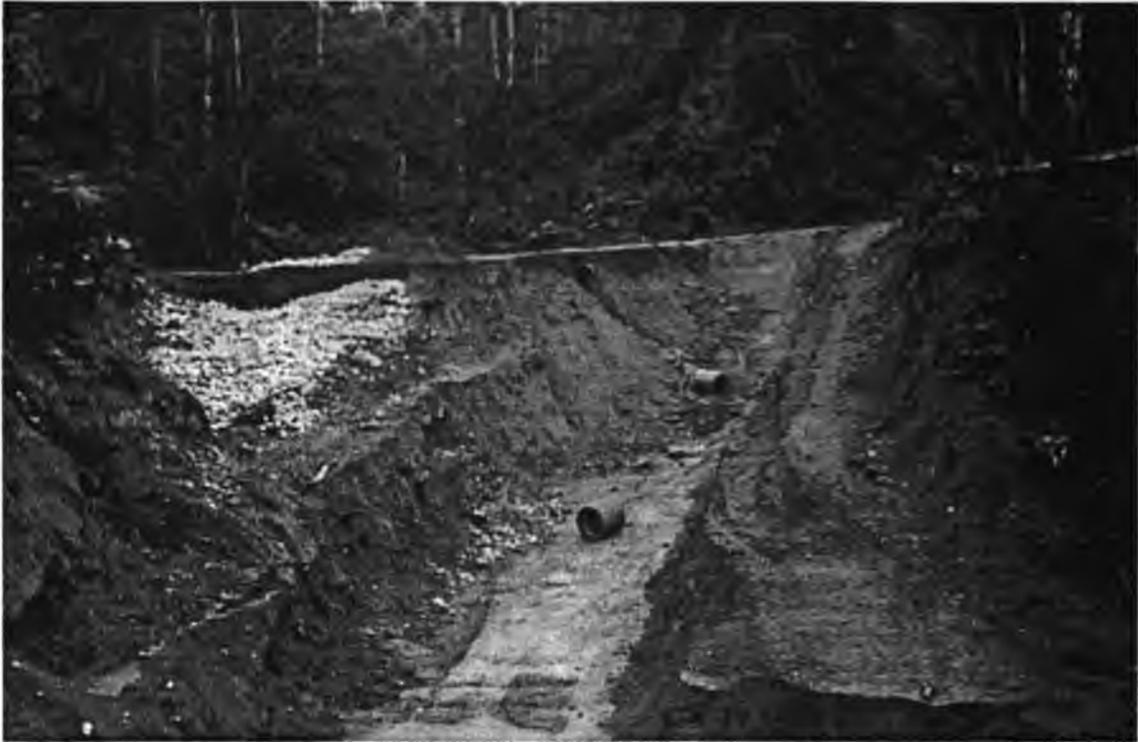
Roads in the rural and mountainous areas were especially hard hit during Hurricane Georges. Many factors contributed to the failure of roadbeds and road drainage systems. Several factors include poor road fill; poorly maintained road drainage ditches, undersized culverts, and blocked culverts. Maintenance and stabilizing road cuts with vegetative and structural methods can reduce the failure of roadbeds and road drainage systems.
